Project Water Bodies Without Borders (EstLat 66)

JOINT MONITORING PROGRAM FOR KOIVA/GAUJA AND SALATSI/SALACA RIVER BASIN

Annex 1 PILOT STUDY

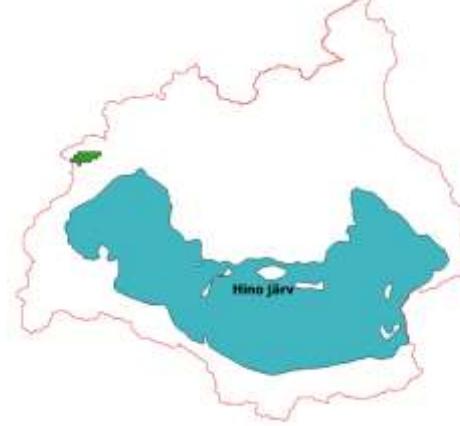
A map showing the location of Hino järv, a large blue lake, within a larger land area outlined in red.
Murati järv	Hino järv

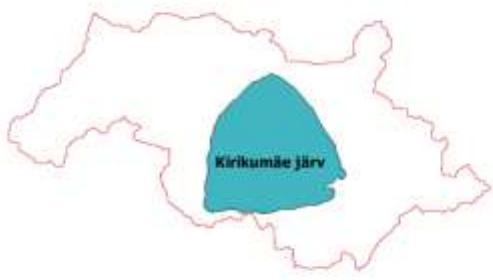
A map showing the location of Kirikumäe järv, a large blue lake, within a larger land area outlined in red.

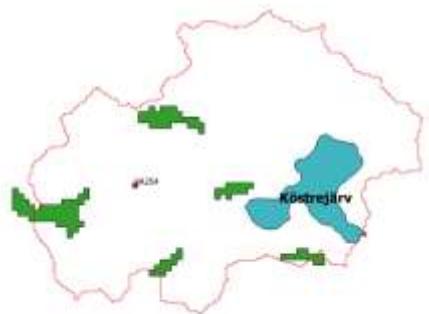
A map showing the location of Kösterjärv, a large blue lake, within a larger land area outlined in red. Other smaller green lakes are also present.
Kirikumäe järv	Kösterjärv

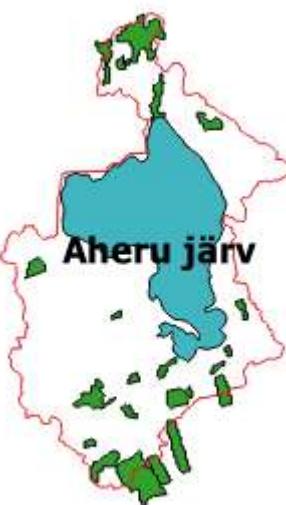
A map showing the location of Aheru järv, a large blue lake, within a larger land area outlined in red. Numerous small green lakes are scattered across the land area.

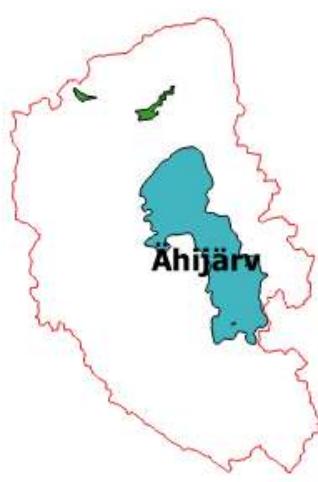
A map showing the location of Ähijäev, a large blue lake, within a larger land area outlined in red.
Aheru järv	Ähijäev

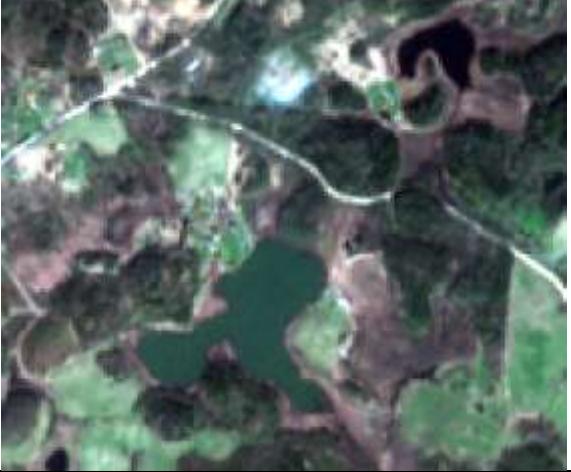
Figure 3.23. Sentinel 2 RGB image 30.04.2018	Figure 3.24. Sentinel 2 RGB image 30.08.2018. Macrophytes are shown with the blue cercle

The evaluation of water transparency for Lake Köstrejärv from remote sensing data have very low reliability because the lake is small and with curved coastline. Also, in late summer large area of lake seems to be covered with macrophytes (Fig. 3.23) and in spring the lake water seems to be very green in color (Fig. 3.24). We could evaluate the water transparency from 6 images and it varied from 0.9-1.5 meters (Fig 3.22). Compared to previous in situ measurements there seems to be slightly decreasing trend of transparency (Fig 3.22).
